CENTRAL INTELLIGENCE AGENCY

INFORMATION REPORT

COUNTRY Poland

SUBJECT Naval Base at Oksywie-Gdynia

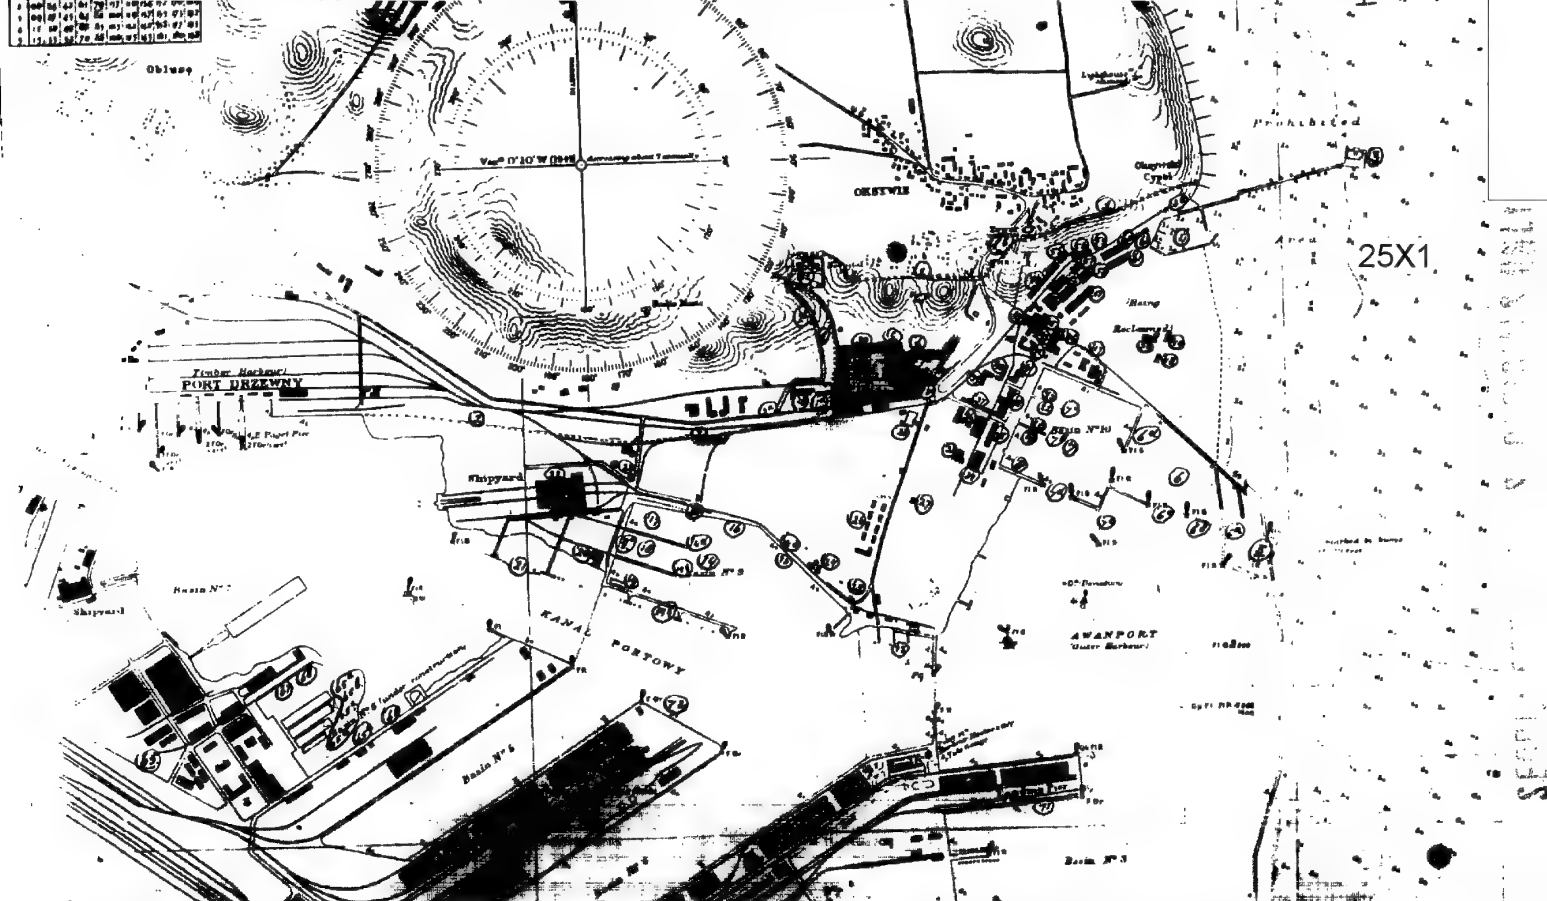
Legend to
~~Sketch of~~ Sketch of "Formosa" Bunker

- b. The bunker is located on the east side of that portion of the pier which runs in a northerly direction. The bunker is three stories high. The first floor of the bunker has an area of about 60 x 40 meters. At the midpoint of the northern side, which is about 60 meters long, is an annex which takes up about one-third of the width.

- c. The upper portion of the bunker is smaller and lies in a northwesterly direction from the center. This upper portion is about 40 meters long, 20 meters wide and 3 meters high.

- e. Wooden pilings had been driven about 10 meters from the sides of the pier and around the bunker to break the force of the waves. (During World War II this bunker was used for testing the firing of guided torpedoes.

- a. Concrete pier
- b. Bunker
- c. Upper structure of bunker
- d. Windows
- e. Wooden pilings for breaking force of waves.

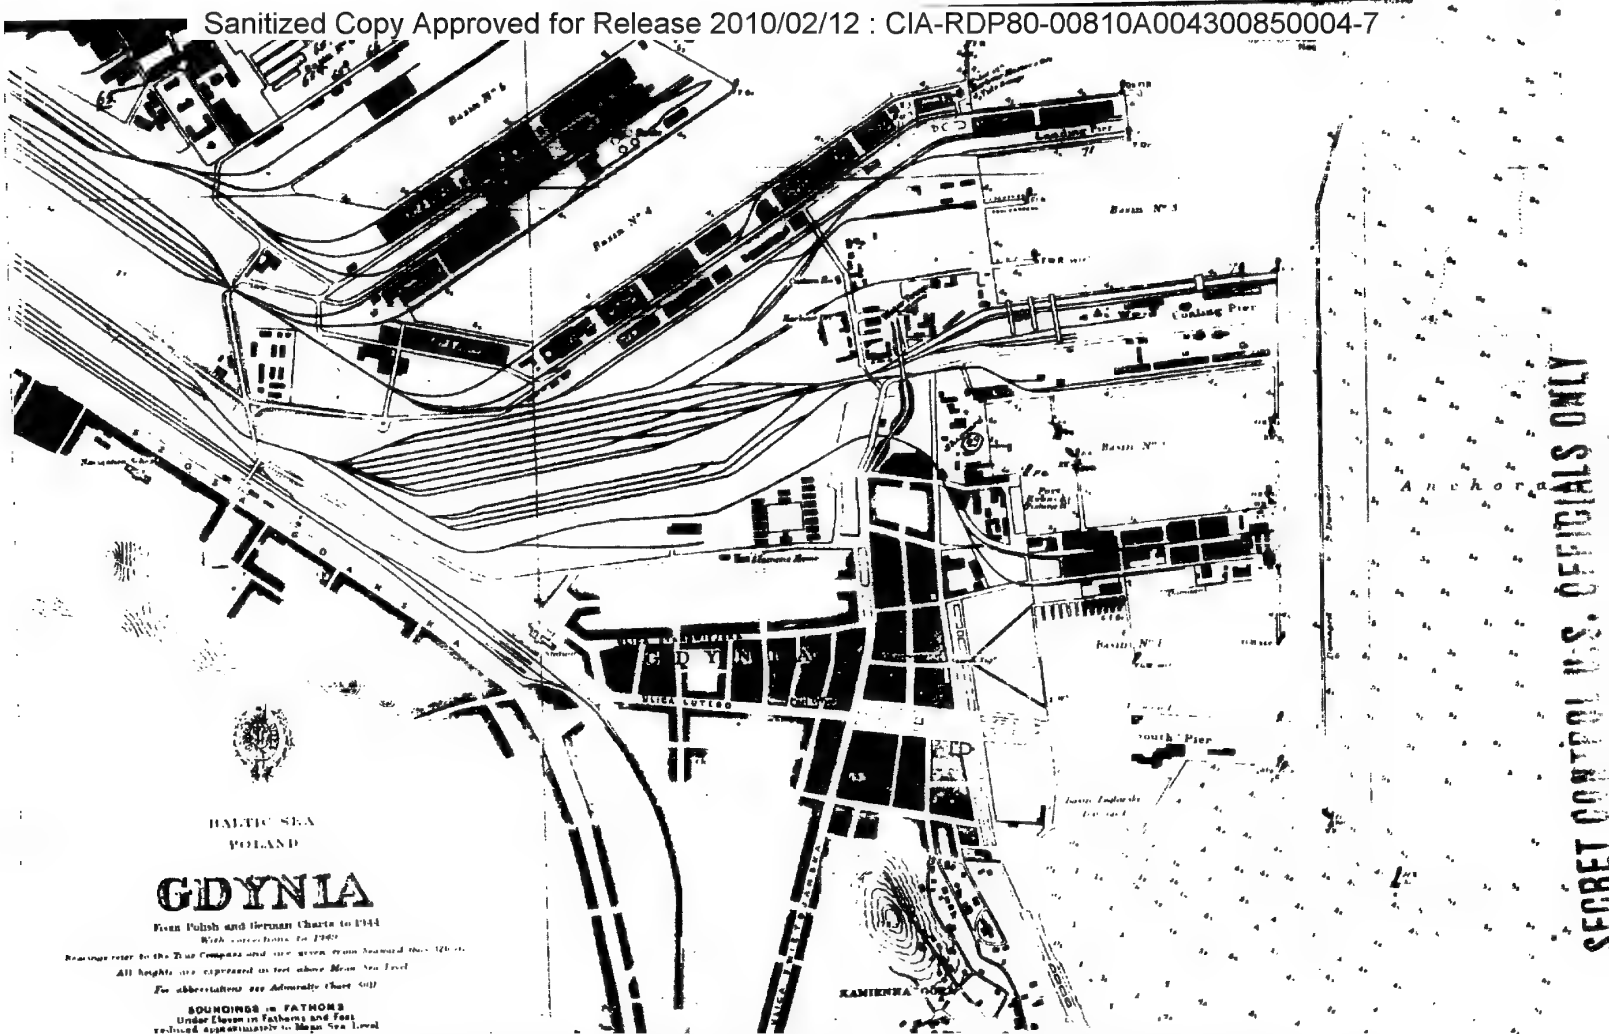
Legend to
~~Object Index for Chart of Gdynia Harbor~~

1. Boundry line of the Polish Naval Base
- 123 ^{Water}
2. ~~Station~~ ^{Railroad}
- 2a Street
- 2b ^{path around naval base} ~~Sidewalk~~ along the ~~barracks~~ grounds

3. Pier with "Formosa" bunker at extreme end
4. Basin
5. Present harbor entrance
6. New basin → 6a, 6b, 6c, 6d, Concrete piers
7. Basin No 10 ^{6c Entrance to #6}

- 8a, 7b Wooden piers
- 7c, 7d Small concrete piers
- 7d, 7e Entrance to ~~basin~~ no. 10
- 8, 9 Berth for ^{four} ~~4~~ to ^{five} ~~5~~ Polish motor speed boats

- 10, 11 Berths for three submarines
12. Berths for ^{six} ~~6~~ minesweepers
13. ^{three} ~~3~~ wooden piers, of which ^{two} ~~2~~ are destroyed
14. Basin No 9 → 14a Quay, 14b Concrete pier, 14c, 14d. ^{Wooden} ~~Concrete~~ piers

15. Wreck of German Naval vessel
16. Berth of the "Byyskawica"
17. Berth for Polish minesweepers
18. Berth for speed boats
19. Repair basin
20. Polish Navy repair shops
